DEPARTMENT OF TRANSPORTATION**DIVISION OF ENGINEERING SERVICES**

Quality Assurance and Source Inspection

Contract #: 04-0120F4Cty: SF/ALA Rte: 80 PM: 13.2/13.9File #: 1.28**WELDING INSPECTION REPORT****Resident Engineer:** Siegenthaler, Peter**Address:** 333 Burma Road**City:** Oakland, CA 94607**Report No:** WIR-024520**Date Inspected:** 20-Jun-2011**Project Name:** SAS Superstructure**OSM Arrival Time:** 700**Prime Contractor:** American Bridge/Fluor Enterprises, a JV**OSM Departure Time:** 1730**Contractor:** American Bridge/Fluor Enterprises, a JV**Location:** Job Site**CWI Name:** William Sherwood**CWI Present:** Yes No**Inspected CWI report:** Yes No N/A**Rod Oven in Use:** Yes No N/A**Electrode to specification:** Yes No N/A**Weld Procedures Followed:** Yes No N/A**Qualified Welders:** Yes No N/A**Verified Joint Fit-up:** Yes No N/A**Approved Drawings:** Yes No N/A**Approved WPS:** Yes No N/A**Delayed / Cancelled:** Yes No N/A**Bridge No:** 34-0006**Component:** Orthotropic Box Girder & Tower**Summary of Items Observed:**

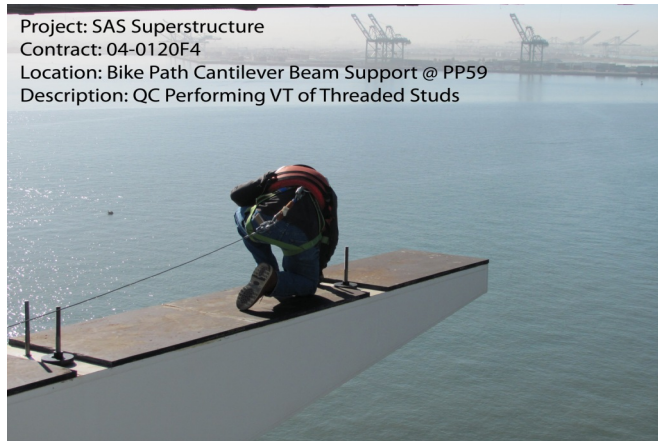
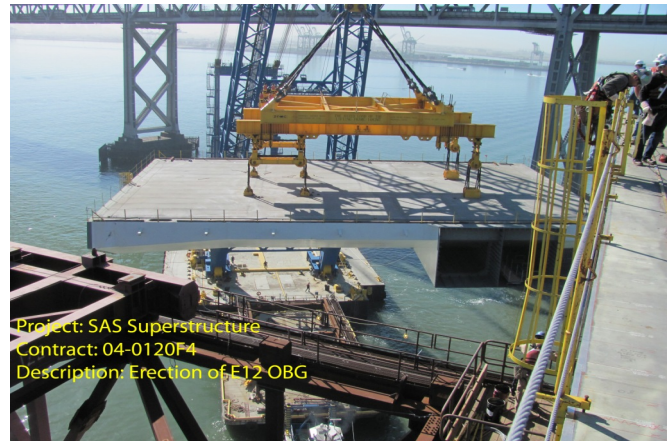
The digital photographs on page 3 of this report illustrate some of the work observed during this scheduled shift.
